# Anonymised completion report extract

## HVLS fan replacement

Two ceiling-mounted fans replaced at an indoor sports facility in Singapore.

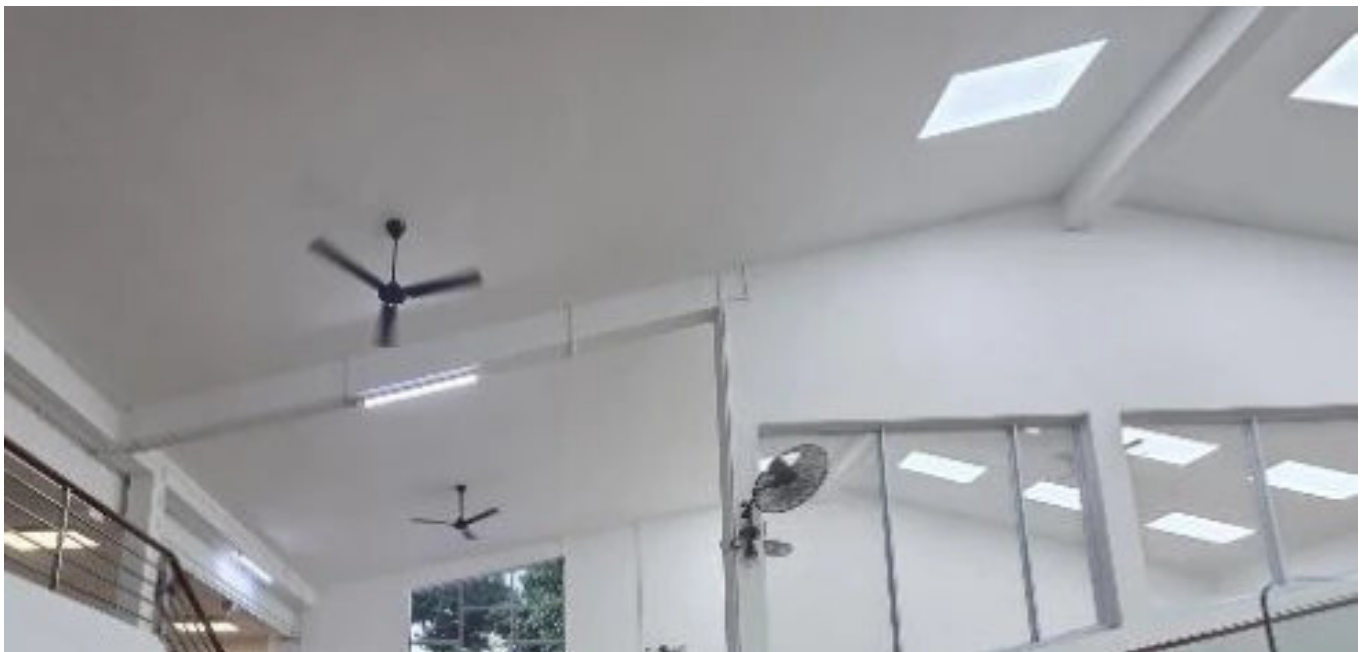
### 01 / Existing condition

Before: the two existing ceiling-mounted fan units.

- Set up safety cordons and height-access equipment; removed the two existing fan units.
- Installed two 2.7 m HVLS fans, with mounting brackets, support beams and safety cables.
- Connected the fans to the existing power supply and installed new controls with remote operation.

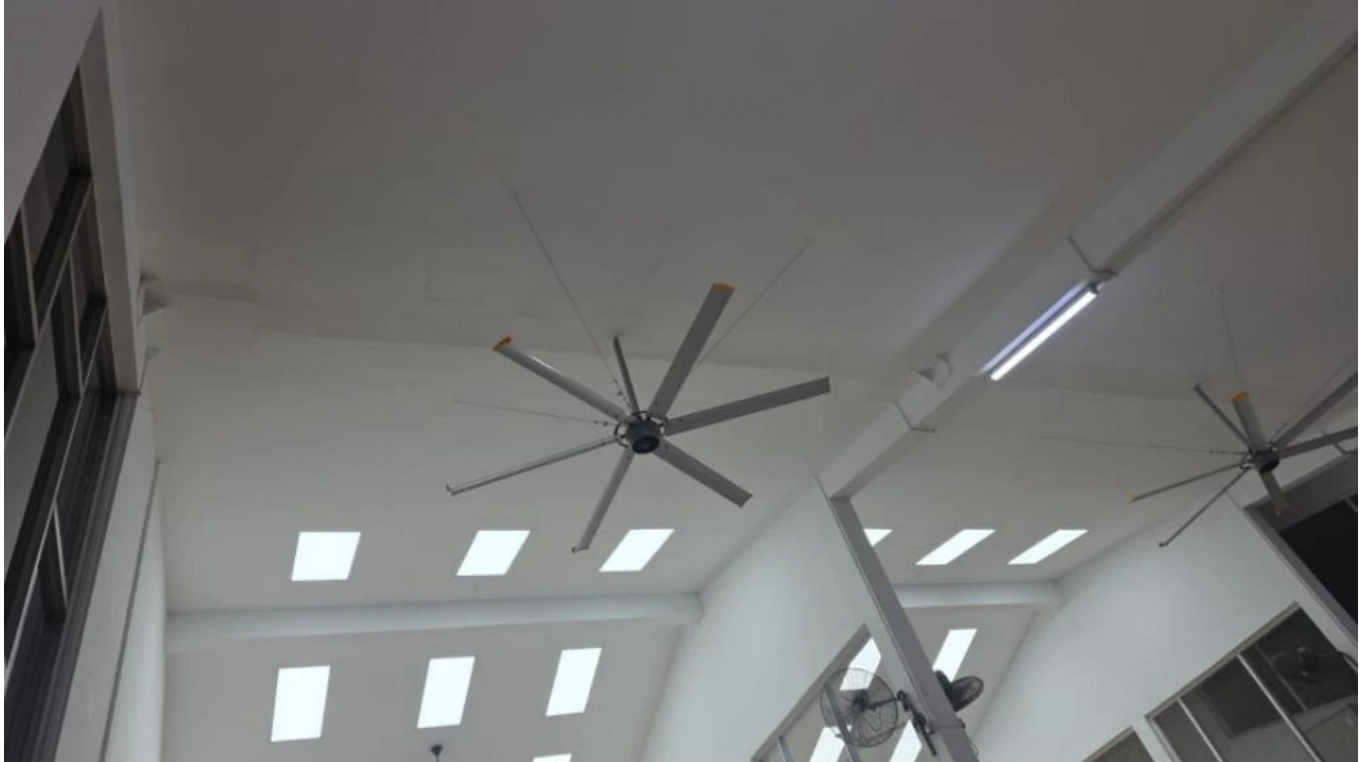
After: the installed HVLS fans.

- Rotation direction, speed control and vibration-free operation checked.
- Fan blades balanced and secured; safety cables installed and anchored.
- Control panels and remotes functional; work area cleared of debris.

**The source report records installation and commissioning as complete.**
